Manhole Inspection Summary

Manhole # S25II_017MH

Location Address: **2200 DRUID HILL AVE**

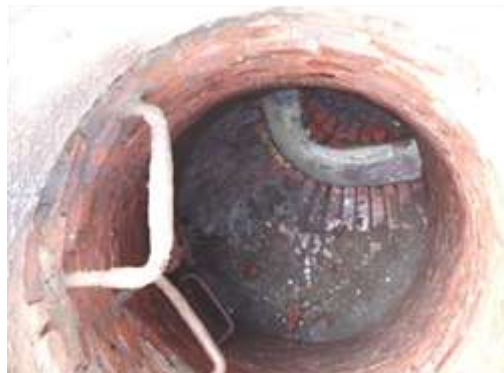
Top View

Corroded steps. Evidence of surcharge - Bench debris.

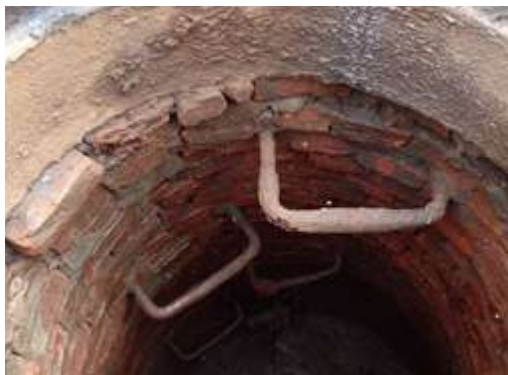
Defect

Frame leaks. Adjustment deterioration, loose brick and infiltration. Corbel and Barrel infiltration.

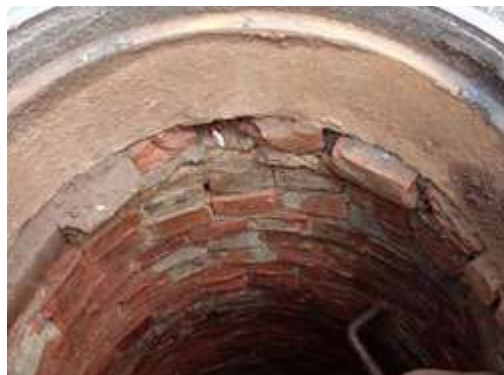
Defect

Frame leaks. Adjustment deterioration, loose brick and infiltration. Corbel and Barrel infiltration - other side.

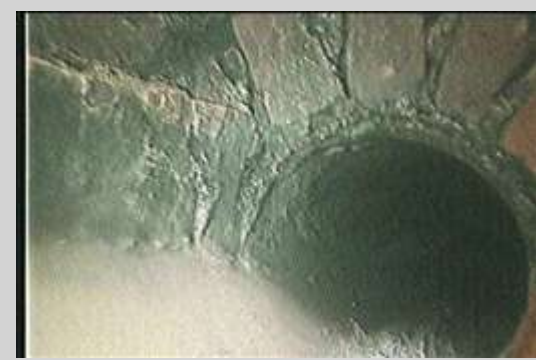
8 in. Circular Gravity Sewer Pipe Out @ 12 O'Clock

Deposits: ☐ None ☐ Mud ☐ Sludge ☐ Debris ☒ Grease

Silt Depth: **0** (in.) Deposits Extent: **Light**

Infiltration: **None** Pipe Seal Cond: **Unknown**

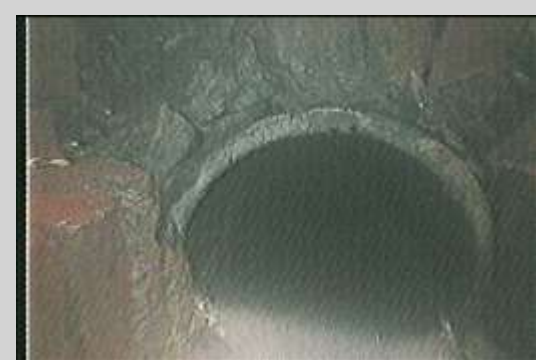
8 in. Circular Gravity Sewer Pipe In @ 3 O'Clock

Infiltration: **None** Pipe Seal Cond: **Cracked**
